## La Condesa Private Railroad Car

## History of “La Condesa”

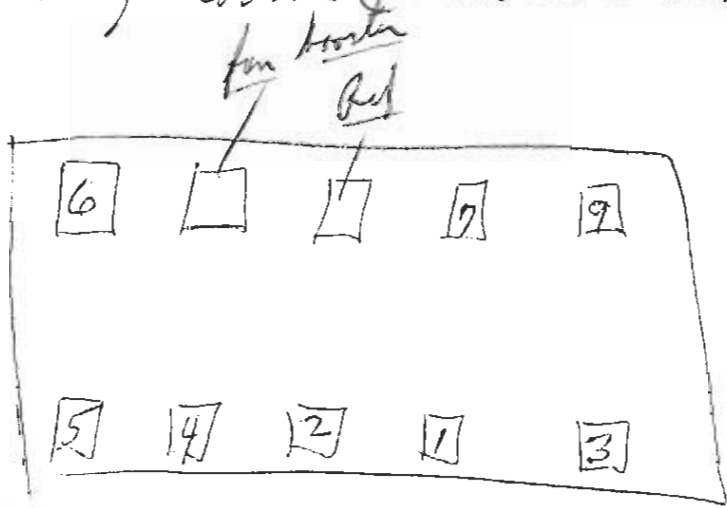
FIG 1

As originally built, this locker contained the main switch panel for all of the car's lighting. It also included switches for the four fans located in the lounge and dining areas before the installation of the air conditioning. See Fig. 1.

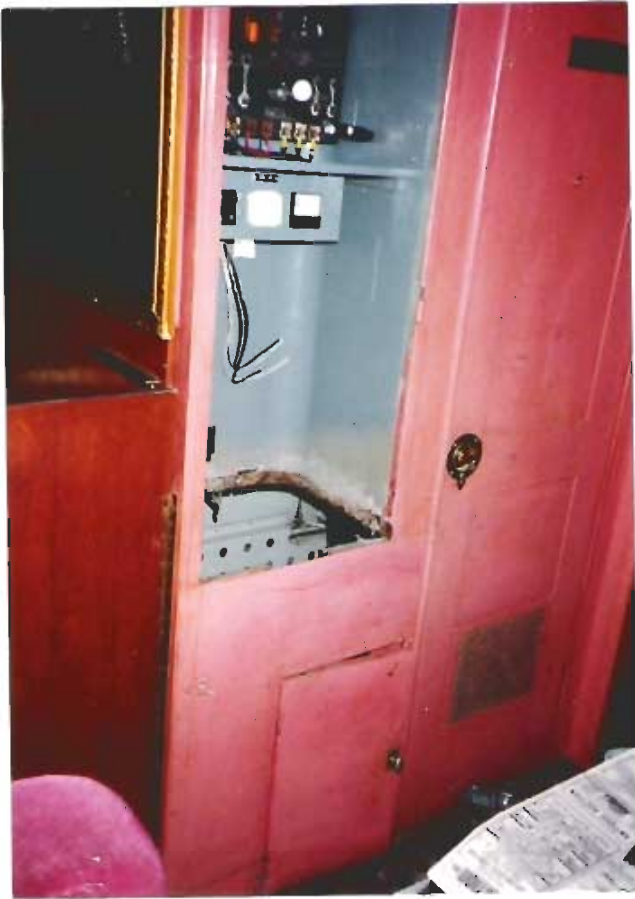
Fig 18

One of the early projects that we tackled was to rebuild the old water cooler locker. This is the small locker to the left of the general toilet door. See Fig. 18. The upper part of this locker contains the old, but still working, air conditioner controls. Directly below these controls is the 32 volt DC control and meter panel. As could be expected, the entire bottom of this locker was rusted out. While we were at it, we added a 1220 volt duplex outlet to the bathroom.

WATER COOLER  
LOCKER

RUSTED OUT BOTTOM

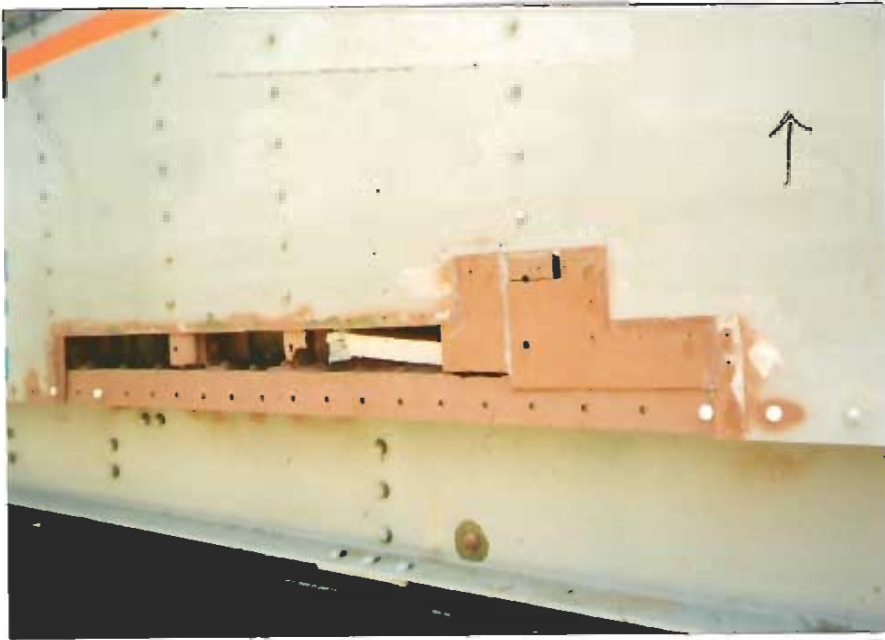
FIG 27

SIDE SHEET  
REPAIR

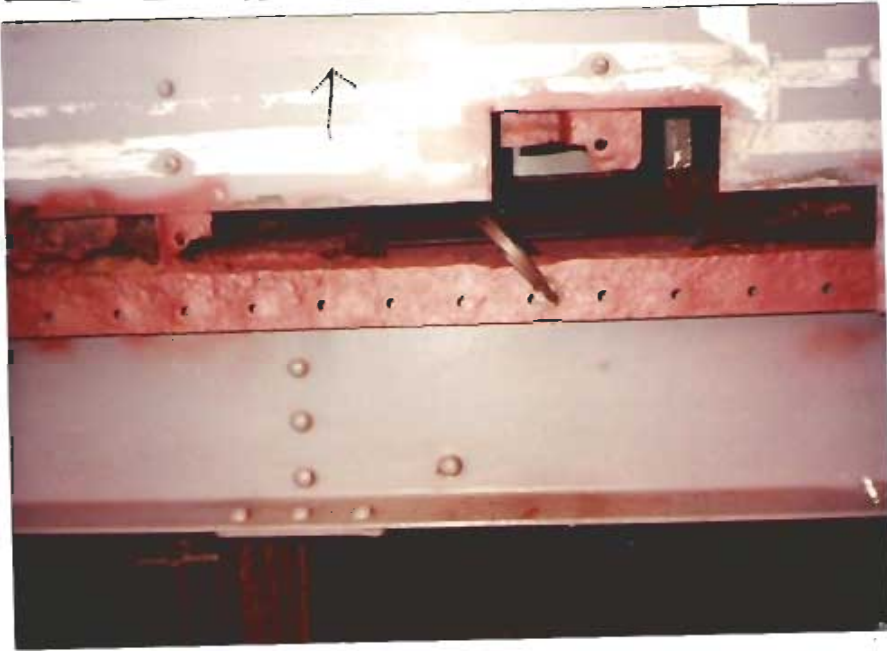
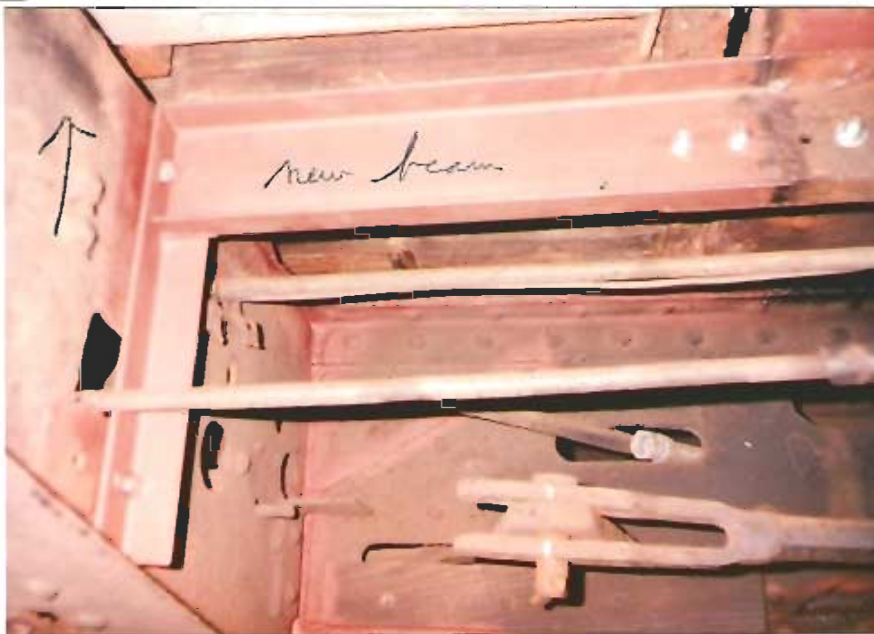
FIG 28

As we continued with this project, we realized that the damaged area was much larger than anticipated. The flooring under the Steward's electric cabinet, which was just behind the old ice box, was also compromised. See Fig. 28. The damage extended inboard as far as the door to BRM C. The board shown in Fig. 28 is the new replacement 2 3/4" by 2 3/4" beam to support the flooring. Note the rusted out floor over the center sill and the new replacement steel. (Middle and bottom photos) See the next three pages for more details on the replacement flooring.

UNDER OLD  
ICE BOX

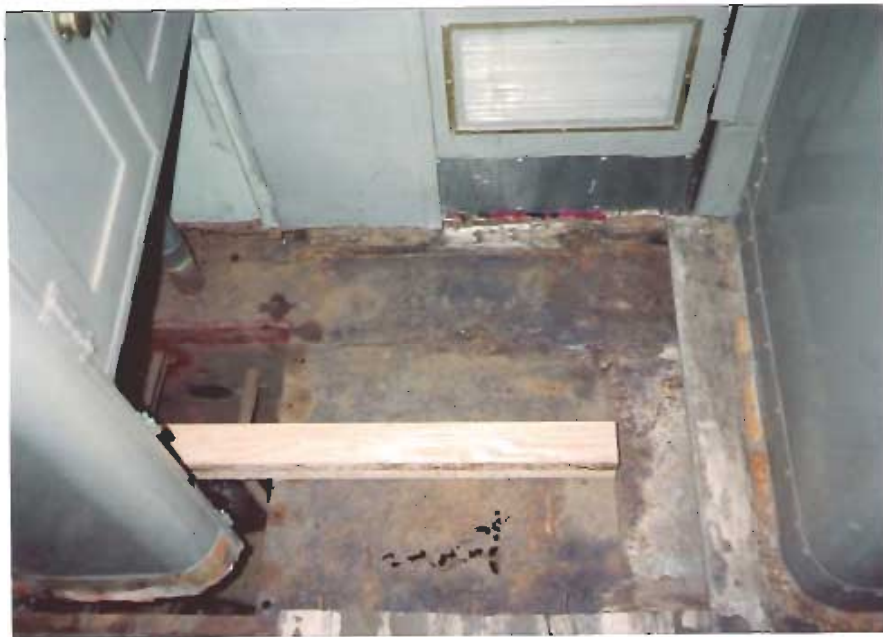
RUST  
OUT AT  
BRM C

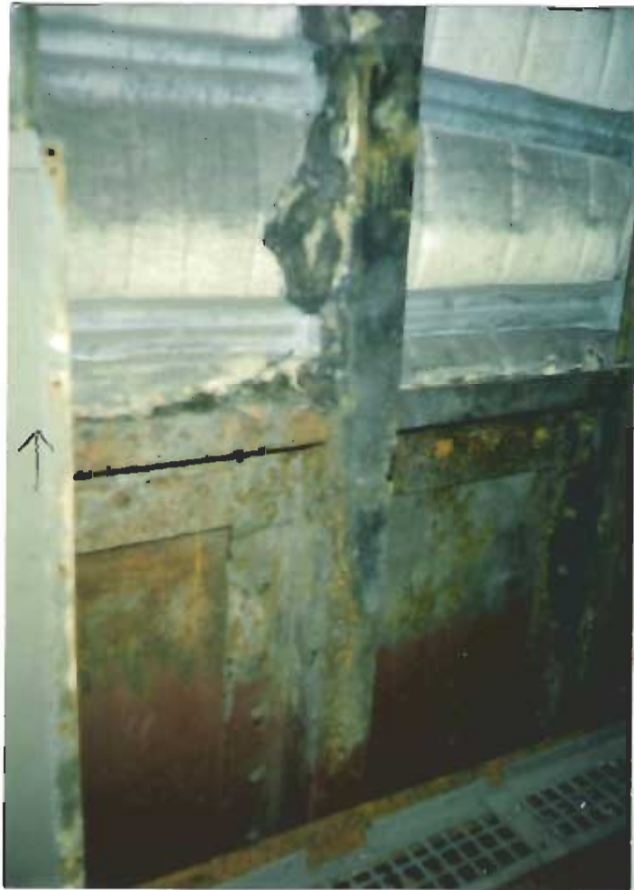
FIG 29

The outside wall of the car that was next to the old ice box also needed some repair. See Fig. 29 for some before and after photos.

INTERIOR  
WALL  
REPAIR

After we finished the interior wall at the old ice box, see Fig. 29, we proceeded up into the ceiling to repair the old ice loading chute.

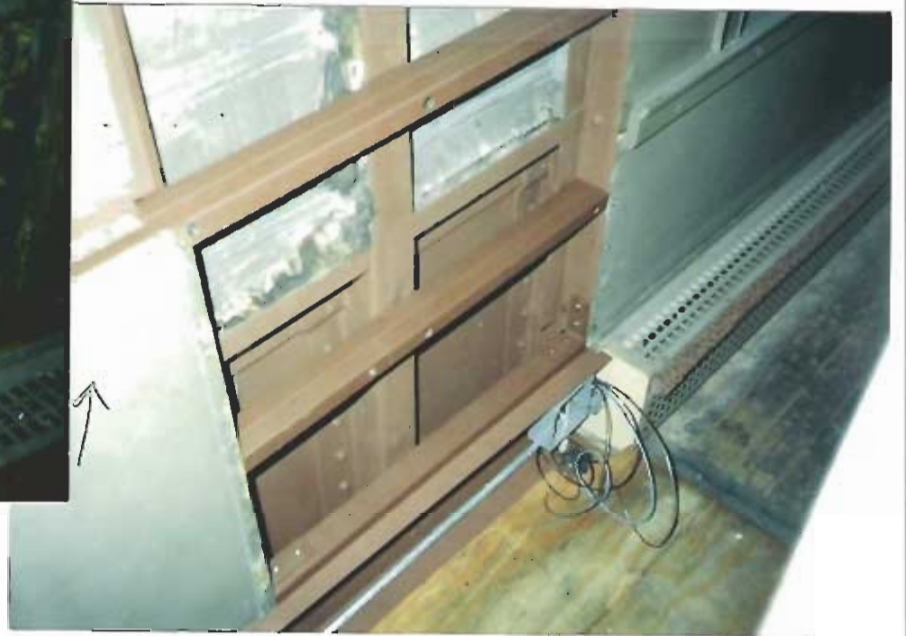
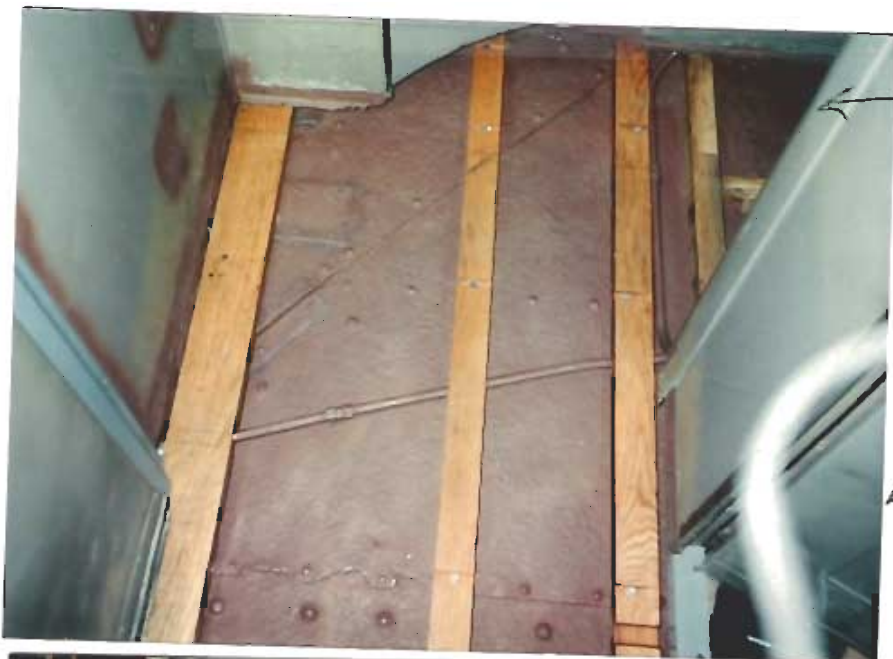
FIG 30

FORWARD  
HALLWAY  
REPAIR

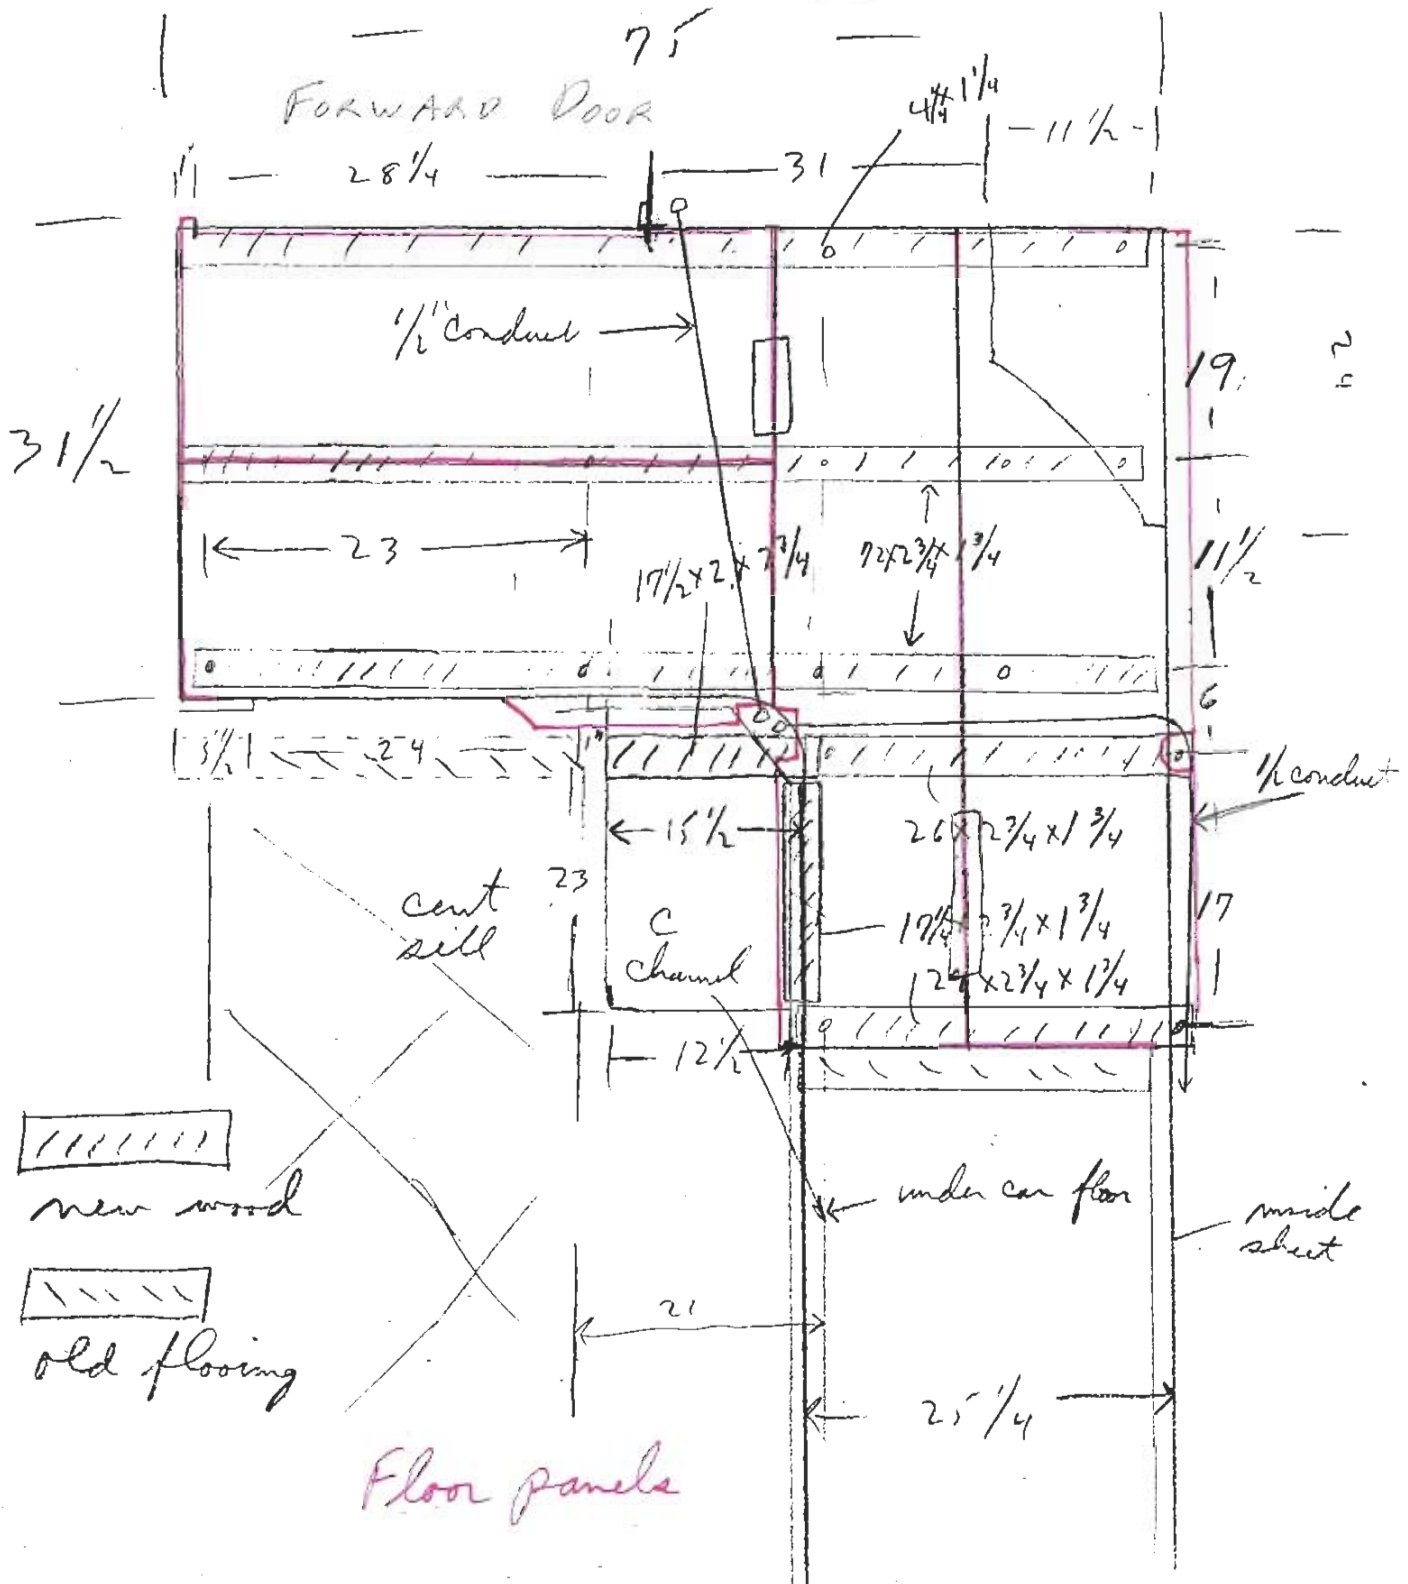
FIG 31 A

After the ice box area was fixed, we then moved on to the forward hall of the car near the doorway. The flooring at this door, by the old kitchen, was also found to be in bad shape. Fig. 30 shows this hallway renovation near the forward door and the door to BRM A. The 1/2" conduit, shown on the floor, is for the forward door bell. In Fig. 31 are some more photos of this work. Fig. 31A is a floor plan showing the new work.

Rear Hallway floor spacing  
FORWARD

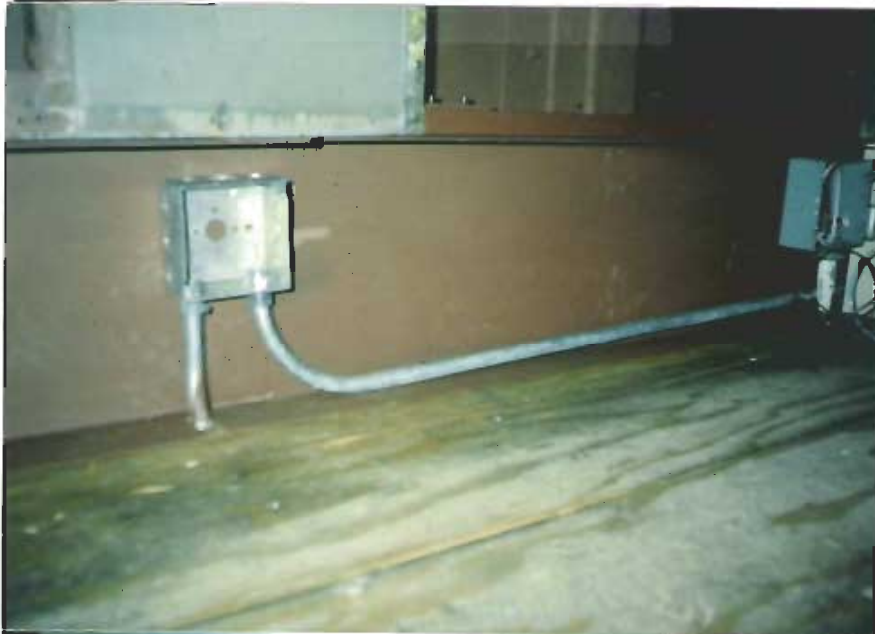
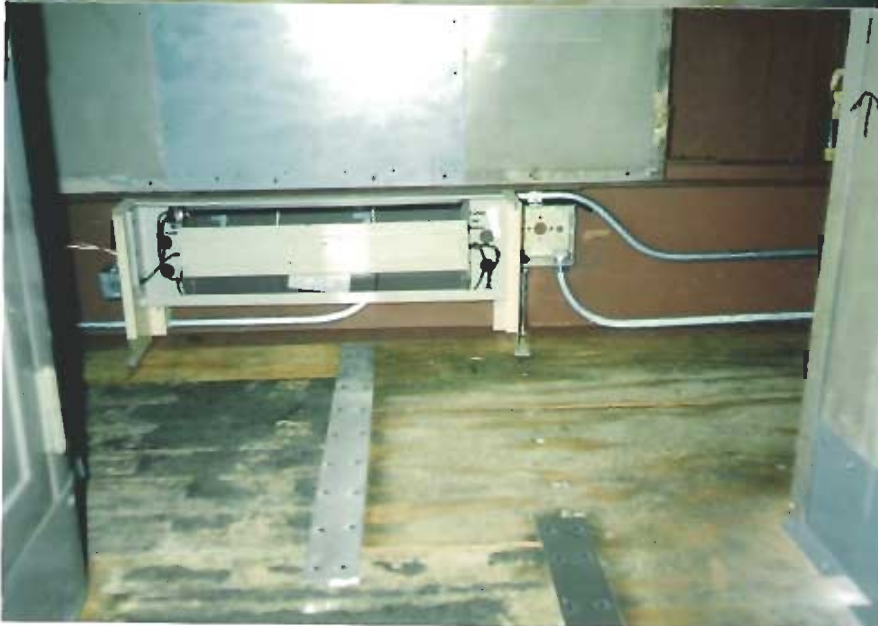
FIG 38

Fig. 38 shows the start of the radiator and conduit installation. The top photo shows one end of the special brackets that were made up. These were used to support one end of the electric baseboard radiators. This picture is at the kitchen radiator location. Two 1/2" conduits were run from the large electric locker near the kitchen to the forward end of the car. One is for power and the other one is for the call bells and telephone lines, a communication conduit in other words. The middle photo is one of the 5" box that is used to connect the communication conduit to another 1/2" conduit that crosses over to the opposite side of the car and terminates in a box in BRM C. More about this later. This conduit is under the wood floor of the car. To the extreme right, in the middle photo, is another 5" electrical box. See Fig. 39. This box, which is connected into the power conduit, has a 3/4" branch conduit that goes under the hallway and connects to the 5" box in the lower compartment of the Steward's locker. See Fig. 33, lower left photo. We used this conduit to connect the hall heaters to the wall thermostat that is in the hallway. From this 5" box, a second 3/4" conduit continues to cross over to the opposite side of the car. This conduit was put in for possible future use, and is under the wood floor. It is from this 5" box that we have 1/2" conduit that passes through the floor to the under car conduits. See Figs. 35 and 36. It was used to connect to the hall thermostat, see Fig. 39A.

The bottom photo in Fig. 38 is of the installation of a 500 watt electric heater under the window in the Steward's section. It also shows the 5" box for the communication conduits.

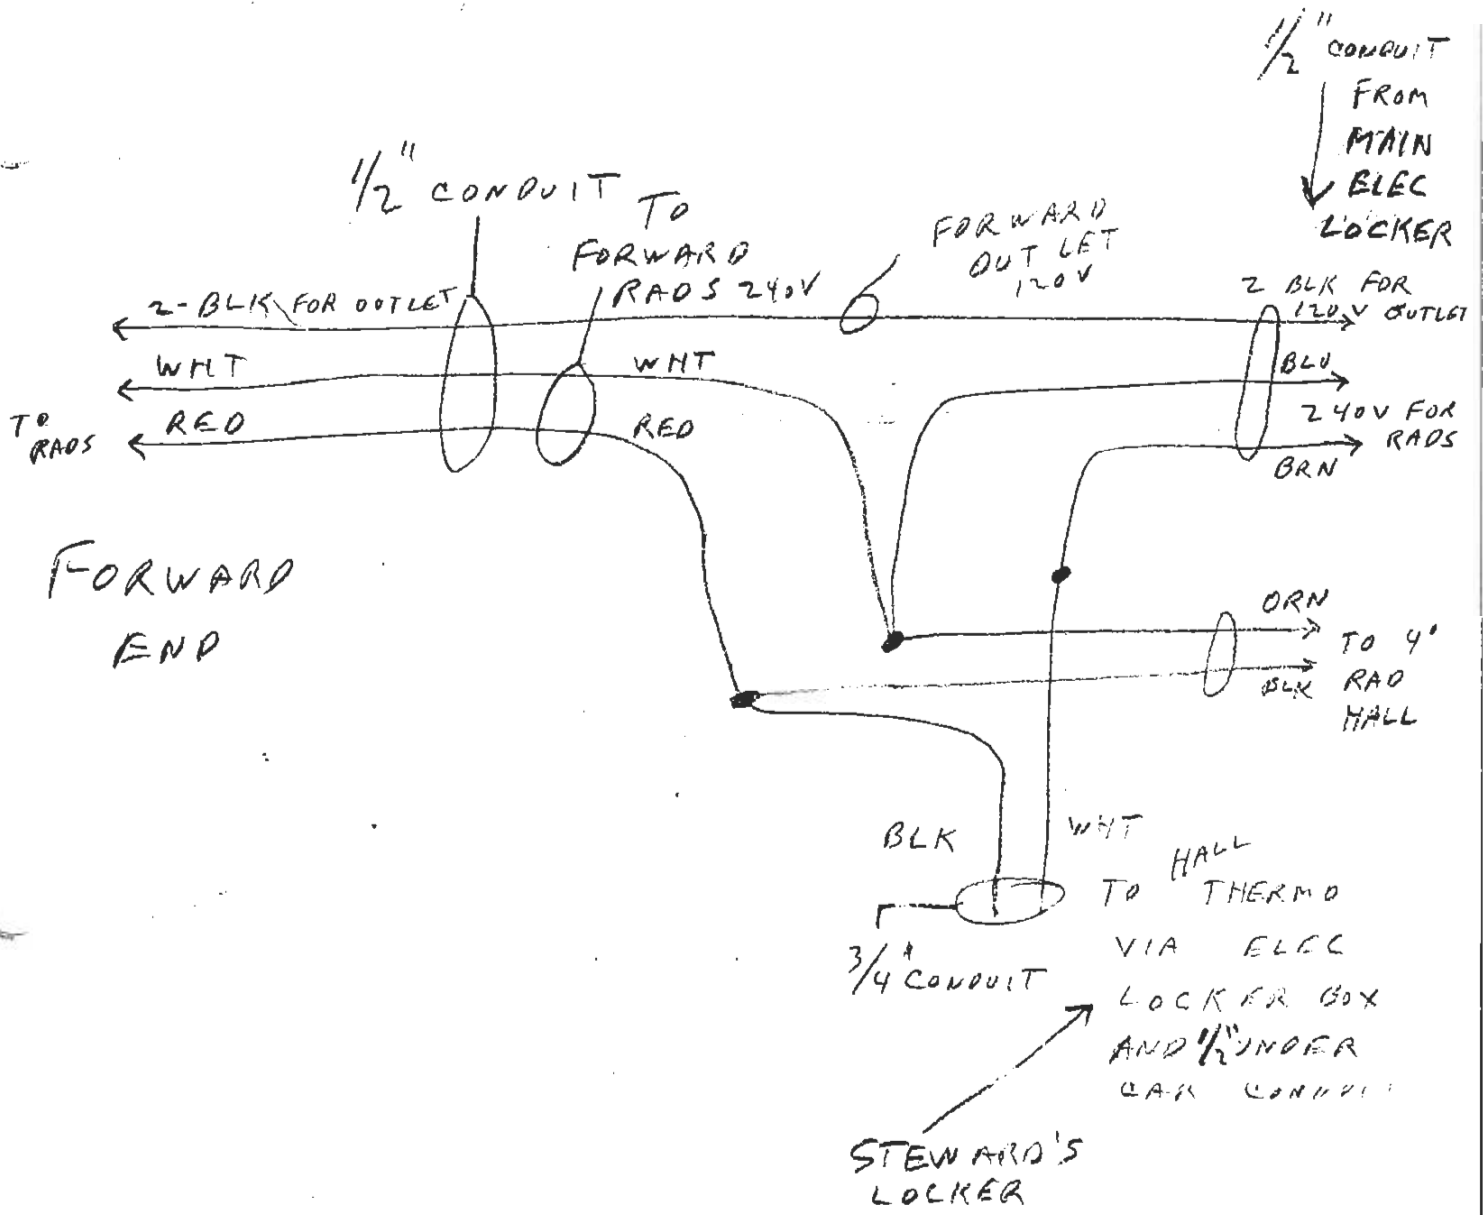
FIG 39A

HALL ELEC WIRING  
AT OLD ICE BOX

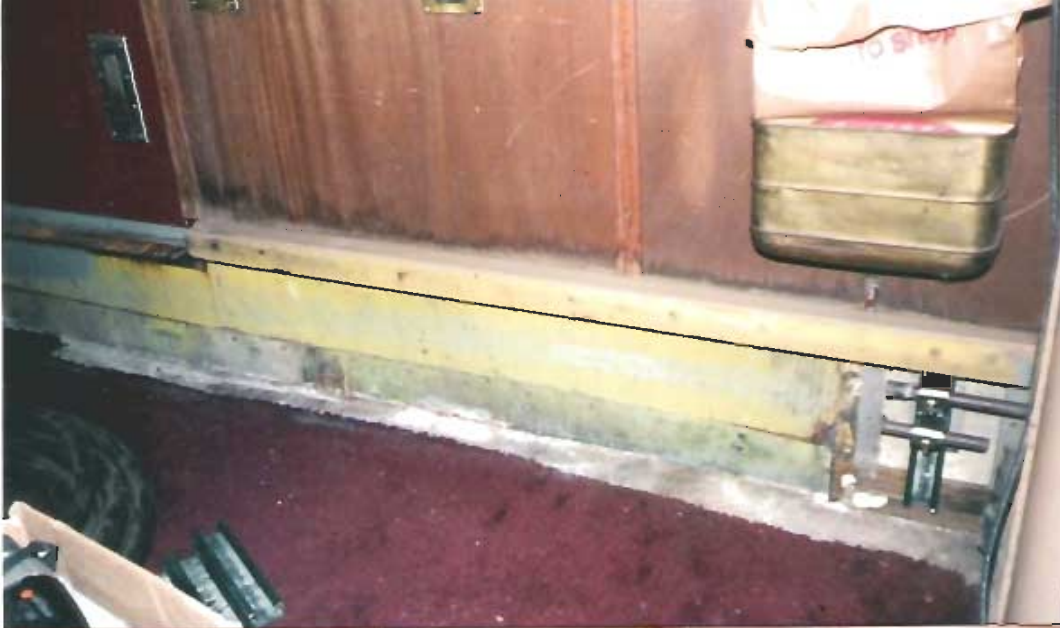
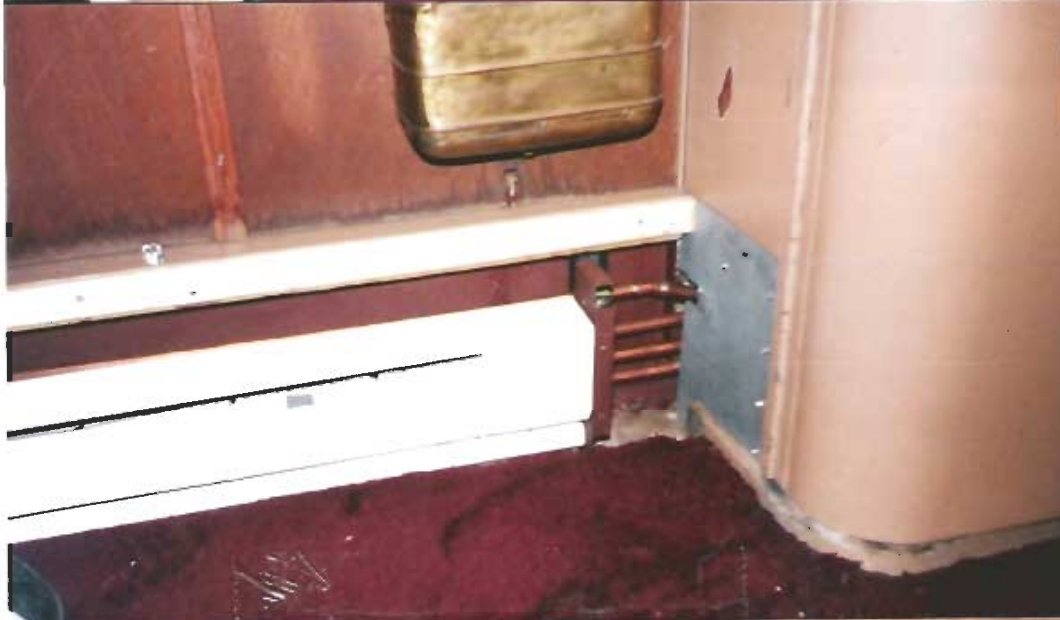
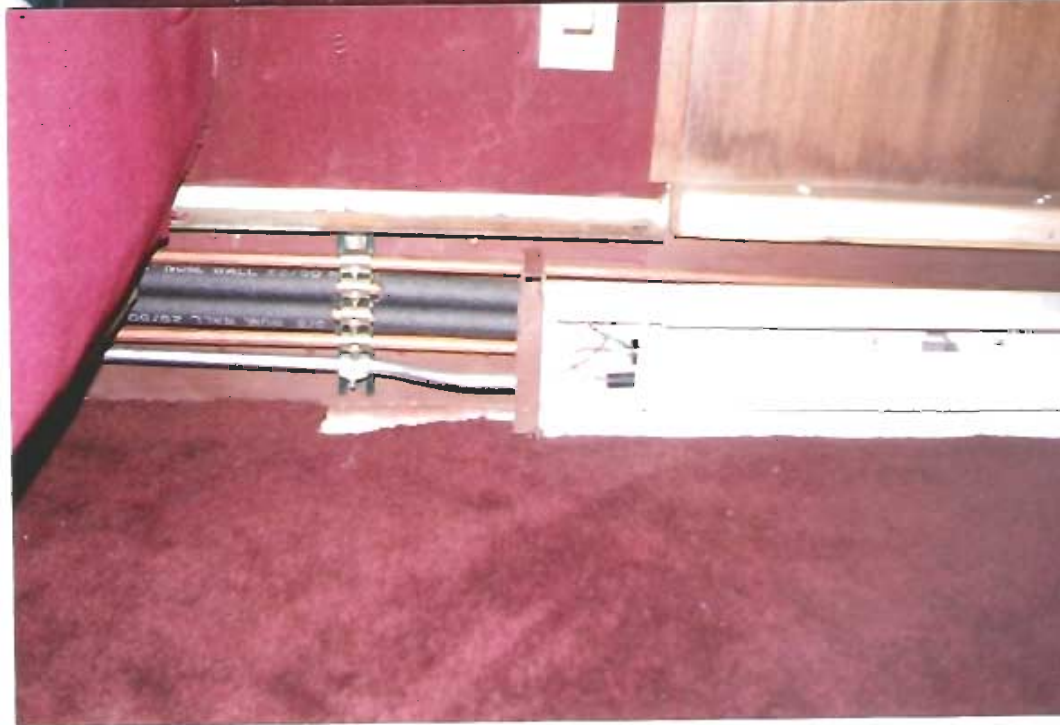
FIG 54

As mentioned before, we removed all of the old plumbing from the kitchen to BRM A. This was necessary because Mr. Finley has used galvanized pipe in several locations and we wanted to add a few things. See Fig. 54 for the work done in BRM A. The top photo is of the space used for the location of the new baseboard heater. This is after we had removed all of the old piping and cleaned up the outside wall of the car. We used "unistrut" to mount the new pipes and conduits. As mentioned previously, we also added two ½" conduits to this side of the car for power and communications. We started out new plumbing at the toilet in this room.

This middle photo in Fig. 54 is after we installed the electric heater using homemade brackets. It should be mentioned that we installed two ½" hot water pipes. This was so that we could install a circulating pump in the hot water lines to keep these pipes hot and in that way save water. One pipe is the feed and the other the return. They are looped together at the toilet. With

We also put in a 1/2" copper line for an air supply to all of the toilets for future installation of "Microphor" toilets. The bottom photo is of the left side of the heater near the sofa seat. To reiterate, the top pipe is the air supply, the next two are the hot water lines, the fourth pipe is for cold water and the bottom pipe is the power conduit. See Fig. 54AS for a schematic representation. Not shown is the finished job with the radiator cover in place.

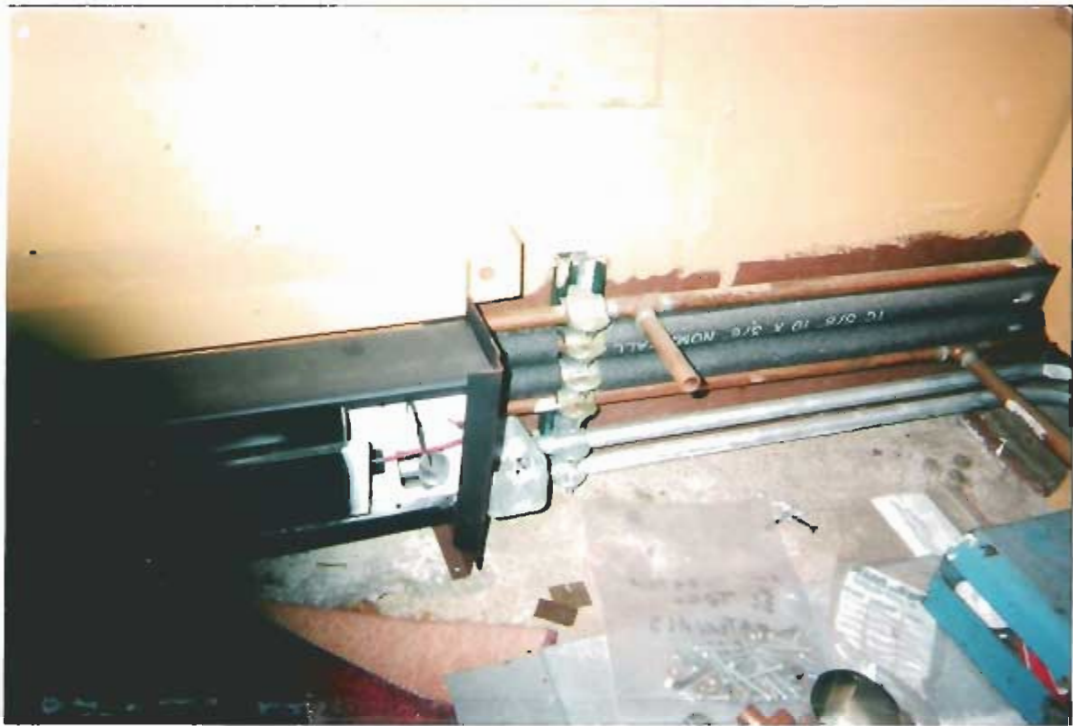
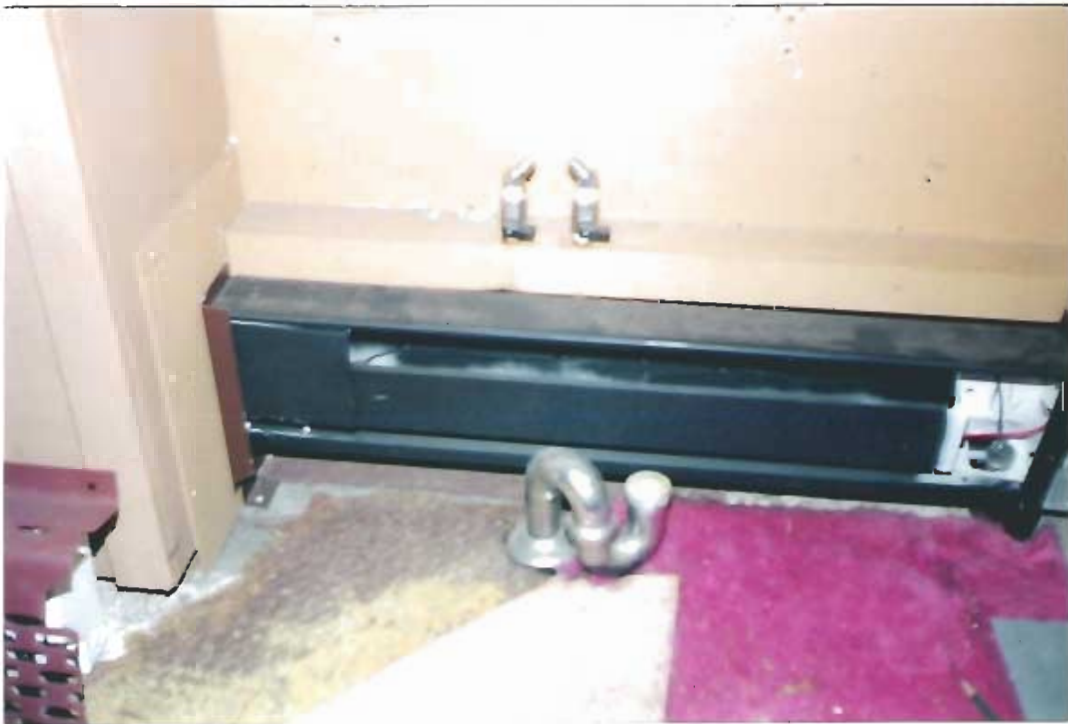
FIG 55

Fig. 55 is of the installation of BRM B. The top photo shows all of the piping in the area that is now behind the "Microphor" toilet. The tap off connections to the air line and cold water pipe are visible. To the left is a small 500 watt heater, mounted also with specially made brackets. The next photo shows the left side of this heater where it abuts the closet wall. The hot and cold water pipe fittings for the sink are protruding through the board used for mounting the radiator cover. The sink drain pipe is in front of the heater. Fig. 55A is a schematic diagram of this room. A thermostat and 120 volt outlet were added to the wall near the sofa seat.

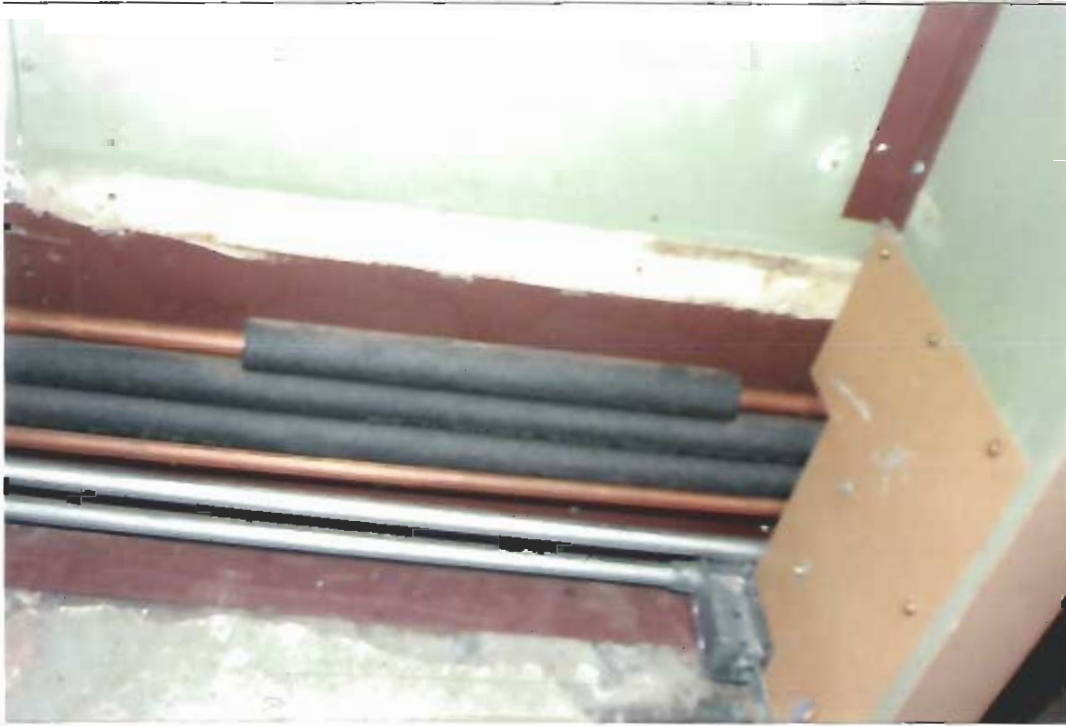
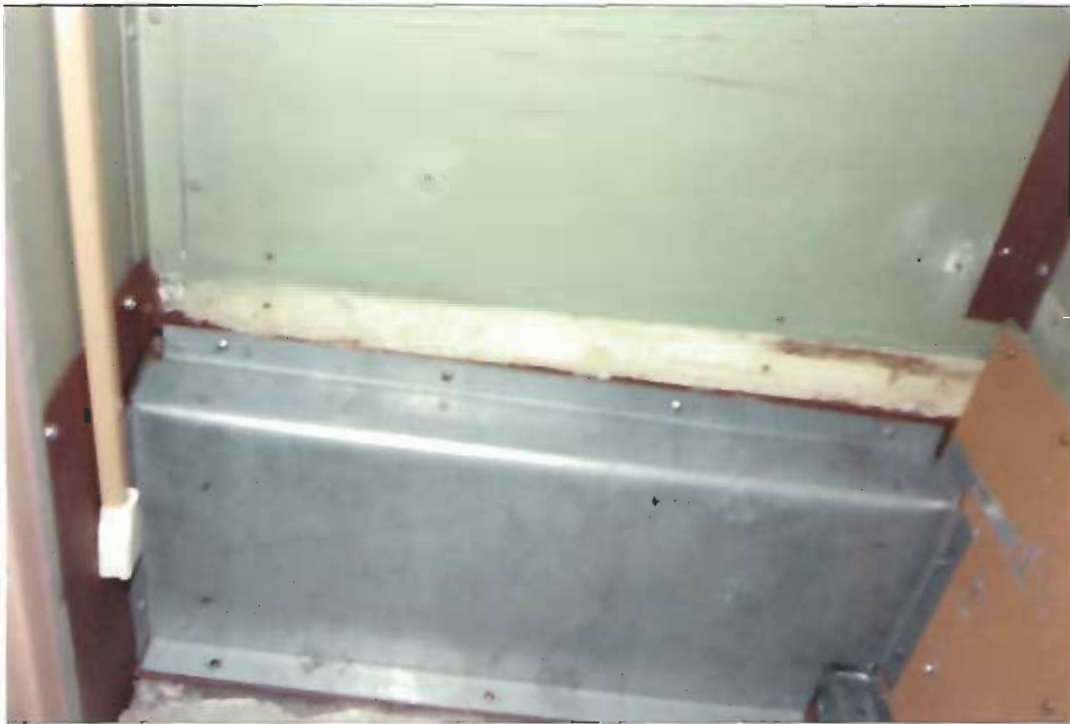
FIG 56

In Fig. 56 the piping is shown as it traverses the bottom of the small closet in BRM B. The top photo is before we installed the cover, which is shown in the bottom photo. Note the small electrical box on the right side,. This is for the call bell connection for this room and is connected into the communications conduit. The "Wiremold" conduit shown on the left in the bottom photo is for the hall thermostat connection.

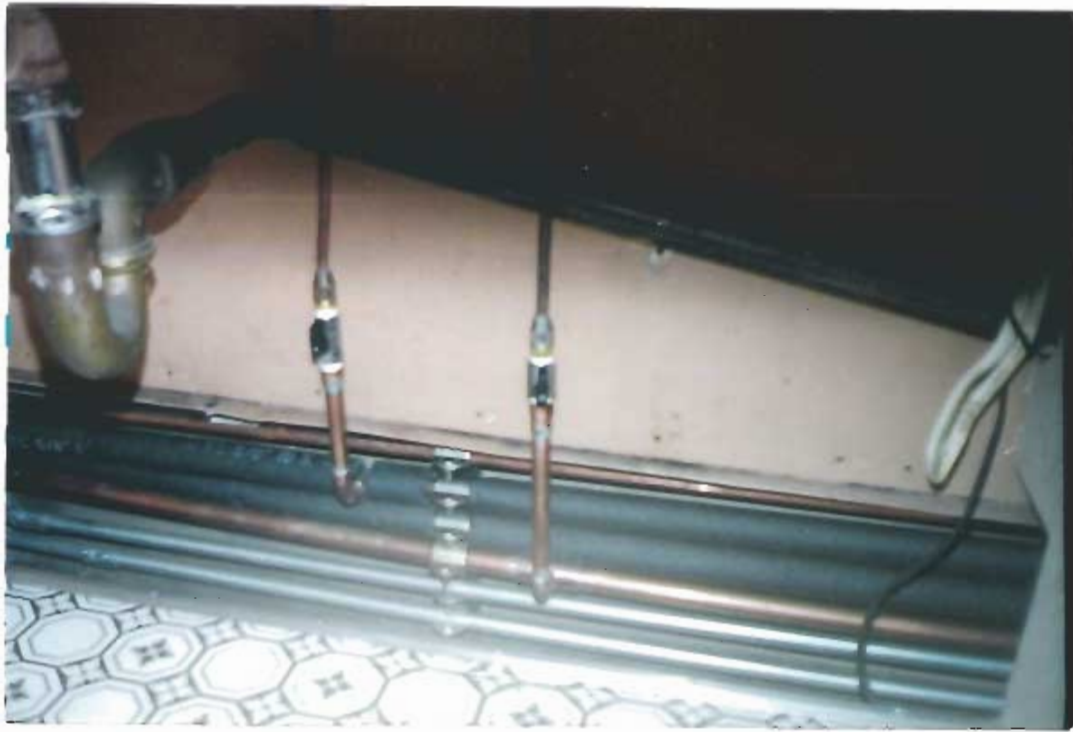
Fig 63

We next moved on to the kitchen. The top photo in Fig. 63 is of the piping beneath the kitchen sink. The bottom photo is of the piping behind the stove. The small pipe in the upper portion of this photo is the gas line to the stove. We had to move all of the pipes away from the wall of the car in order to get into the locker, which was the next location for the plumbing. Fig. 63A is a piping diagram for the kitchen and the adjacent closet.

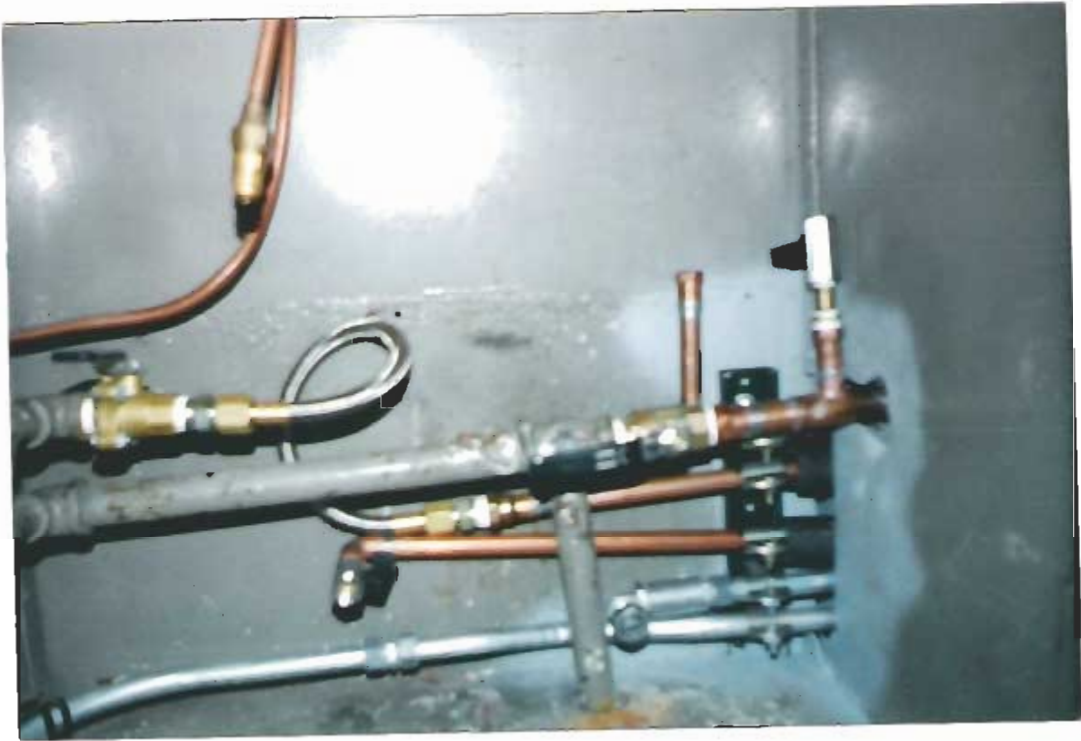
Fig 64

The closet or locker next to the kitchen stove is where we ended our plumbing job. Fig. 64 is a photo of where we left off. The main water feed for the car comes up through the floor in a ¾" brass threaded pipe. We added a shut off valve into our ¾" copper feed line. We also added a tap off for a pressure gauge, which was mounted on the wall above the stove. This gauge will read the actual water pressure. A tap off was also added into the air line and a second gauge was mounted next to the first one. This gauge will read the air pressure to the toilets. Our ½" hot water feed line was temporarily connected to the old brass hot water line as it comes from the general toilet,. We included a shut off valve in this line and it is the stainless steel flexible pipe shown in the photo. We naturally capped the hot water return line. The communication conduit was connected to the rest of the system. See Fig. 51A. The power conduit has not been connected since we elected to bring all of the necessary wiring up through the 4" box shown in Fig. 57. Fig. 64A may be of some help in locating the various pipes.

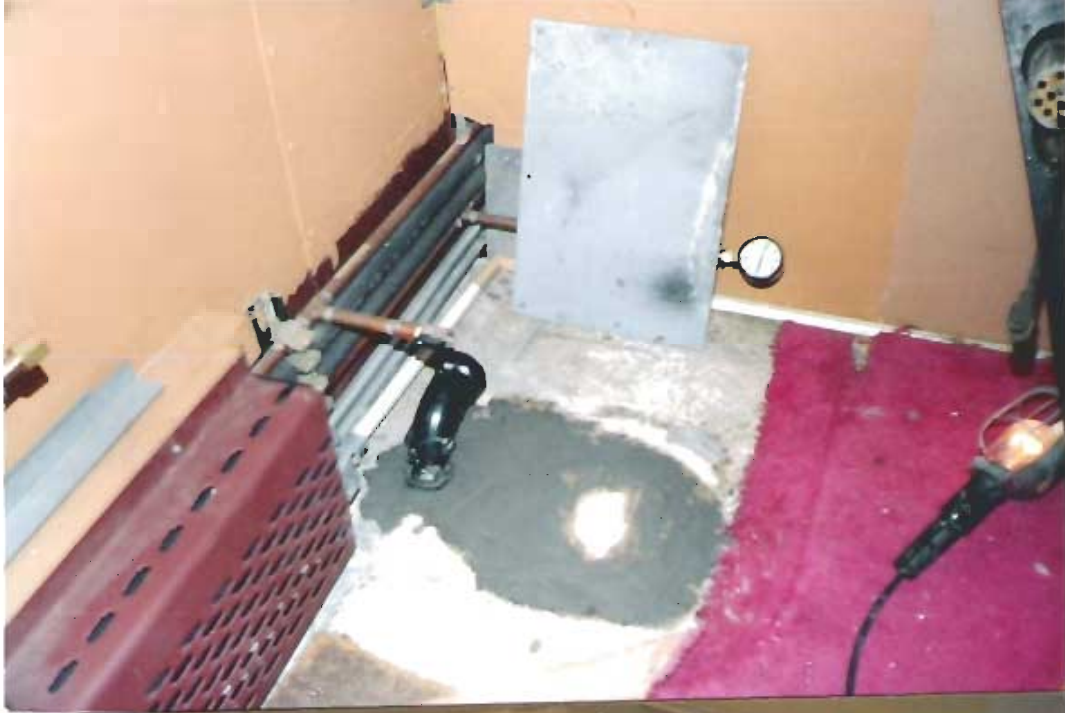
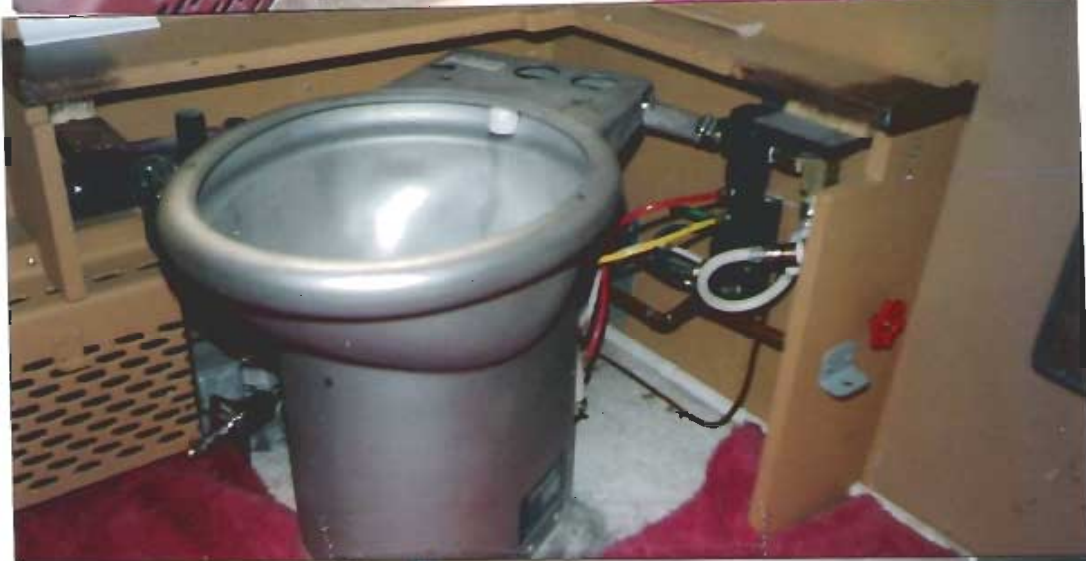
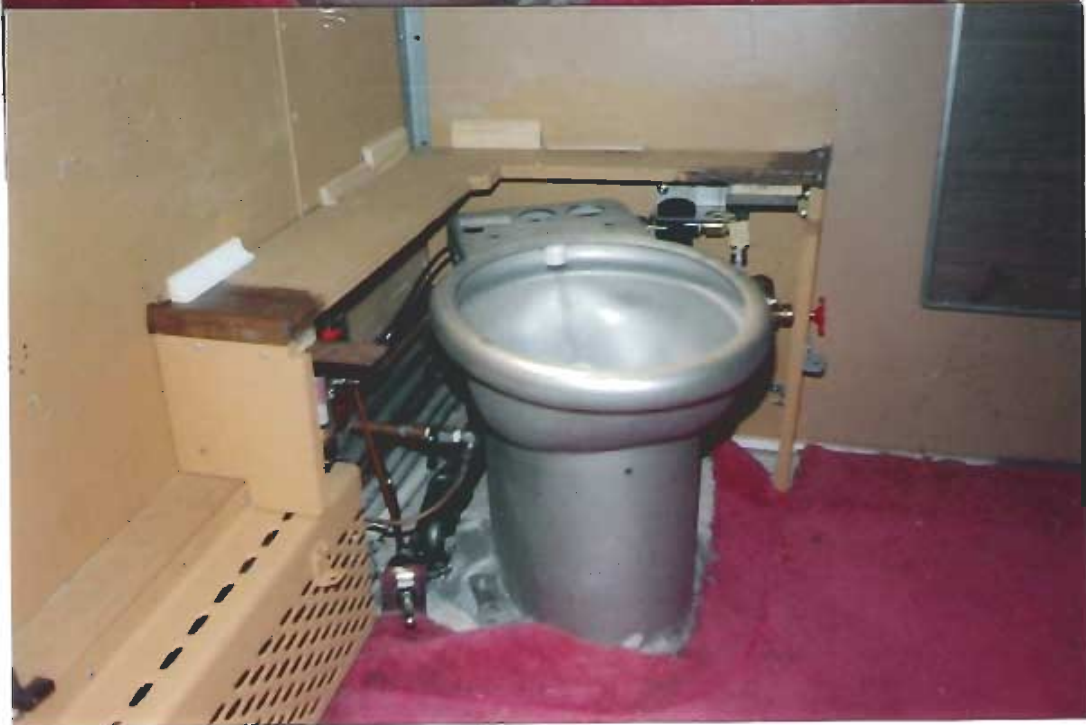
F  
1  
6  
65

Figs. 65 and 65A show the installation of the "Microphor" toilet in BRM B. The top photo, in Fig. 65, is after we plugged the old toilet drain hole that went through the floor. The black PVC pipe is the new drain. The middle photo is after we installed the wood frame from the old toilet housing, the toilet itself, and all of the air and water lines. We wanted to utilize the old toilet housing as much as possible. The air sequencing valve with its multiple colored hoses can be seen against the back wall. The red knob protruding from the wood housing is to shut off the water supply in the event of a failure of the sequencing valve to shut off the water. The bottom photo is another view of the installation. We wanted to preserve the old toilet's unique pull up knob feature to flush so we had to mount the actual flush knob near the floor. Note its location on the floor near the end of the radiator grill. The air pressure regulator and oiler are located on the left side wall.

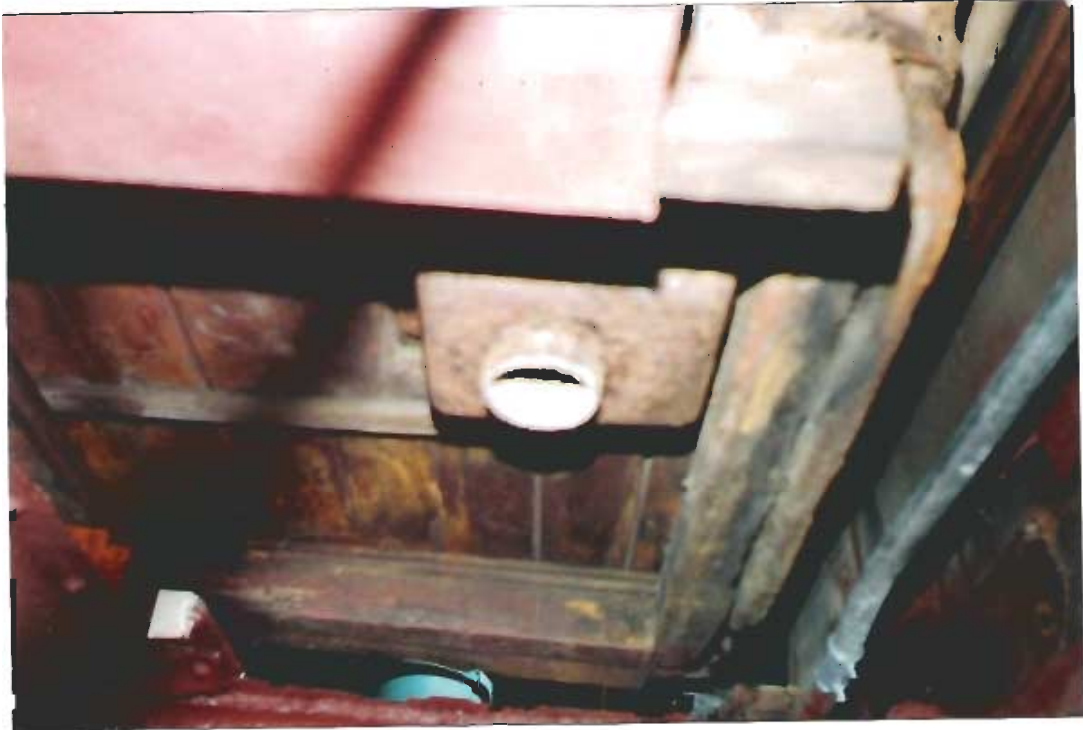
Fig 66

Since this sanitation tank is directly under the shower, we had to repair the wood beneath the shower before installing the tank. Fig. 66 shows the underside of the shower before restoration. The round tube in the center is the old ice box drain, now the shower drain. This drain had to be routed around the new holding tank. The photo shows some of the rotted wood. A new ½" conduit is on the right. The photo was taken before the floor repair work in BRM C was completed, so you can see right into BRM C. The blue object is a tank vacuum cleaner in this bedroom. See Figs. 66A and 66B for more details.

SHOWER FLOOR  
outside view
