## La Condesa Private Railroad Car

## History of “La Condesa”

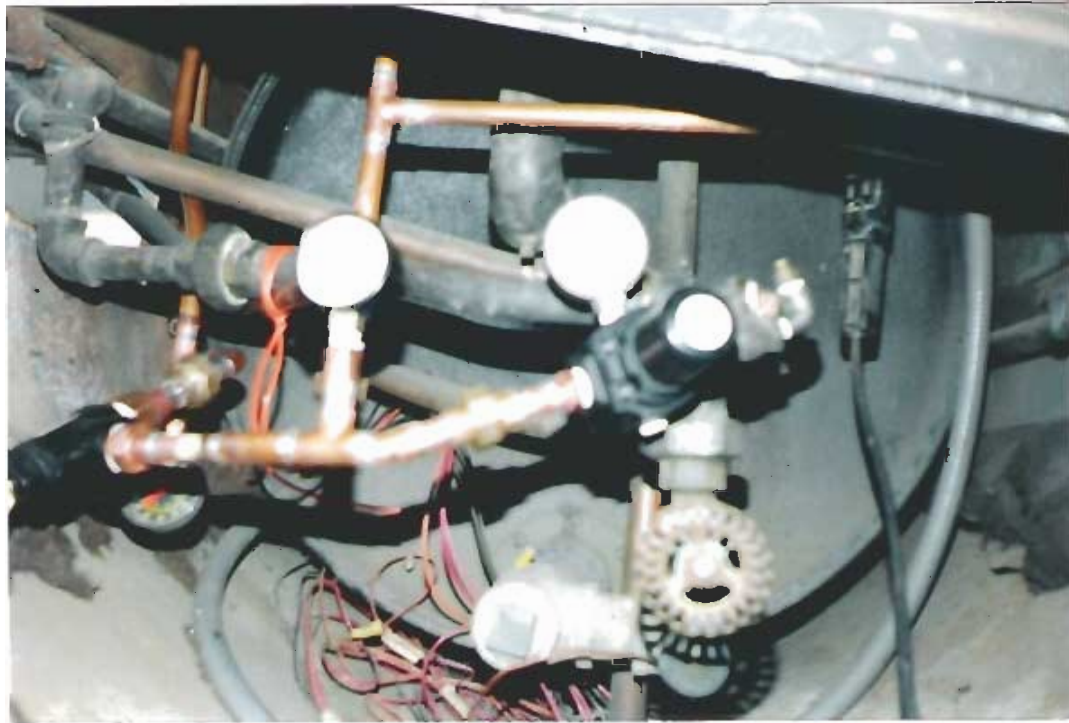
Fig 67

In Fig. 67 the black item with the handle, which is on the left, is the governor valve. The regulated is on the right with the gauge on the top. We added three air gauges, one to measure the brake pipe pressure, one to indicate the APW tank pressure, and one for the water tank pressure. The wires shown in the water tank housing are for the eventual installation of the water tank protection heaters, the kitchen stove, and for the kitchen outlets. See the first page after Fig. 40 for more details. In Fig. 68 and the following pages are shown the old governor and reducing valves.

All railroad cars used air pressure to bring the water from the under car tank up into the car. The old water raising system used a governor and a reducing valve to accomplish this. We had to replace these units due to leaks. See Fig. 68 for more details of the old valves that Pullman had installed. Someone may be able to rebuild them. Fig. 67 shows the new repiping of the air system in one end of the water tank. We replaced the old reducing valve with one manufactured by Wilkerson and the governor valve with one by Teel.

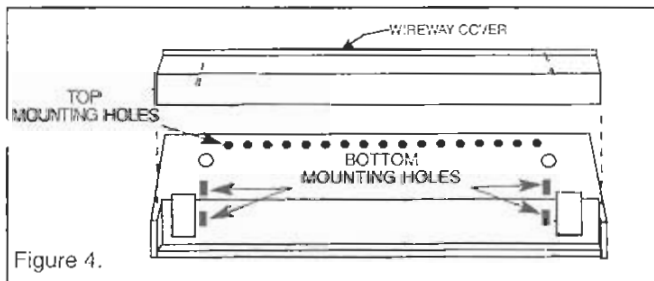
Figure 4.

6. Position heater to wall (use mounting holes as a guide, see Figure 4) and secure through the top row of predrilled mounting holes using at least two fasteners, one at each end of the heater. If the unit is mounted above the floor to allow carpet installation under the heater, two additional mounting holes are supplied at each end below the element. This will allow you to screw into the sill plate if the unit does not span across two wall studs.

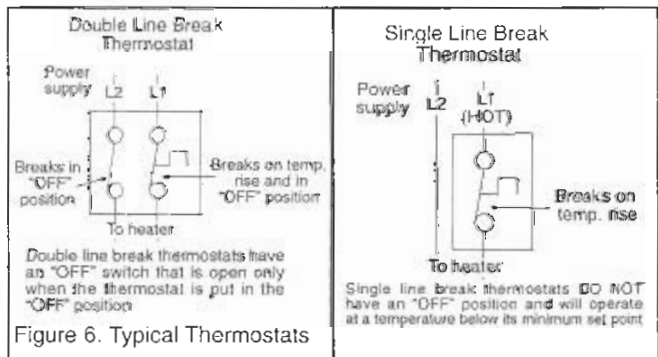
Figure 6. Typical Thermostats

9. If front cover was removed, reinstall by hooking the top edge on the support bracket(s). Then push down to latch onto the support bracket(s).
10. Replace wiring compartment cover.
11. Follow instructions accompanying thermostat for installation and wiring thermostat. See Figure 6 for typical thermostat wiring diagrams.

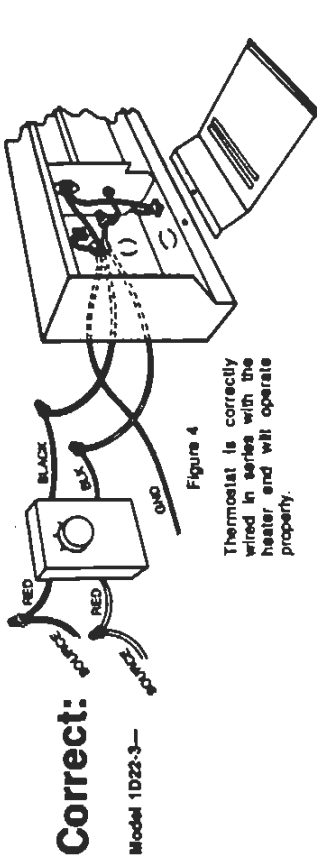
Figure 4

Thermostat is correctly wired in series with the heater and will operate properly.

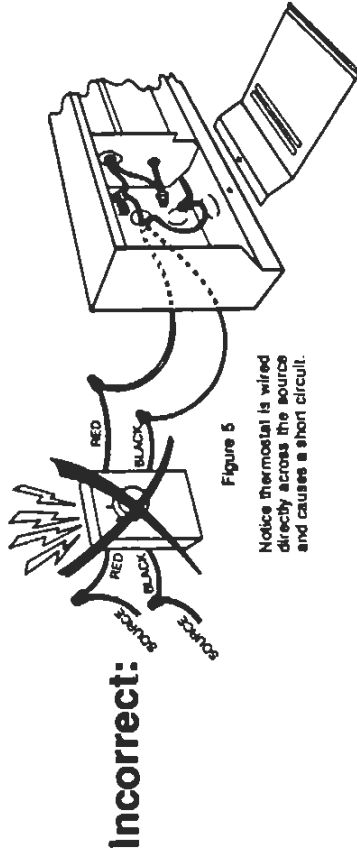
Figure 5

Notice thermostat is wired directly across the source and causes a short circuit.

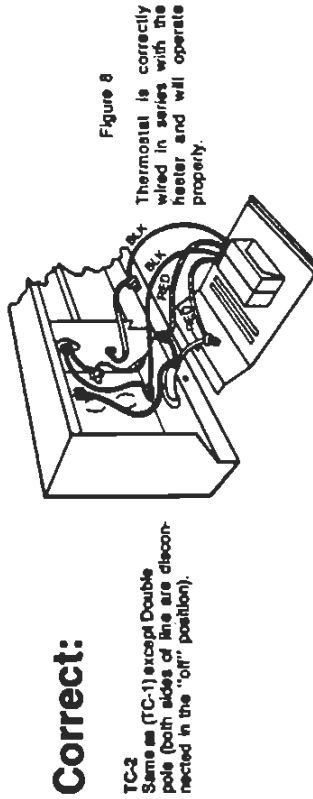
Figure 6

Thermostat is correctly wired in series with the heater and will operate properly.
